POL PIER REPAIRS LAJES FIELD AZORES(U) OLKO ENGINEERING 1/1  
NEW YORK FEB 83 CHES/NAVFAC-FPO-8365.2  
DACA51-79-C-8123

POL PIER REPAIRS  
LAJES FIELD , AZORES

FINAL FIELD INSPECTION REPORT  
FEBRUARY 1983

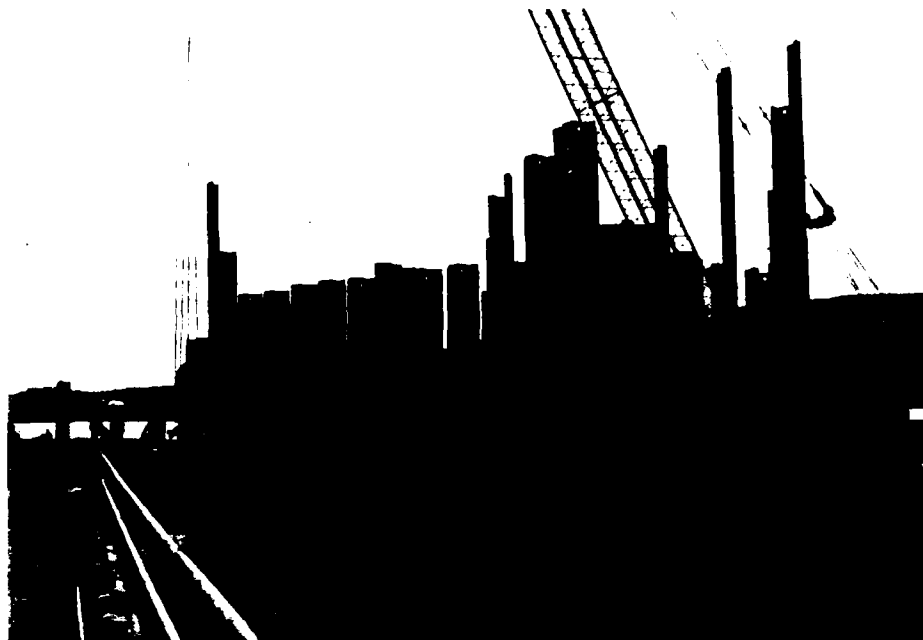
NEW NORTH DOLPHIN  
Epoxy Paint Touch Up of Abraded Sheet Piles.

The steel sheeting of the new North Dolphin requires considerable touchup on the exterior surfaces. The corrosion protective coating had been abraded during handling. In some areas there is evidence of touchup, but apparently not all areas were corrected, or after the touchup, additional abrasion occurred.

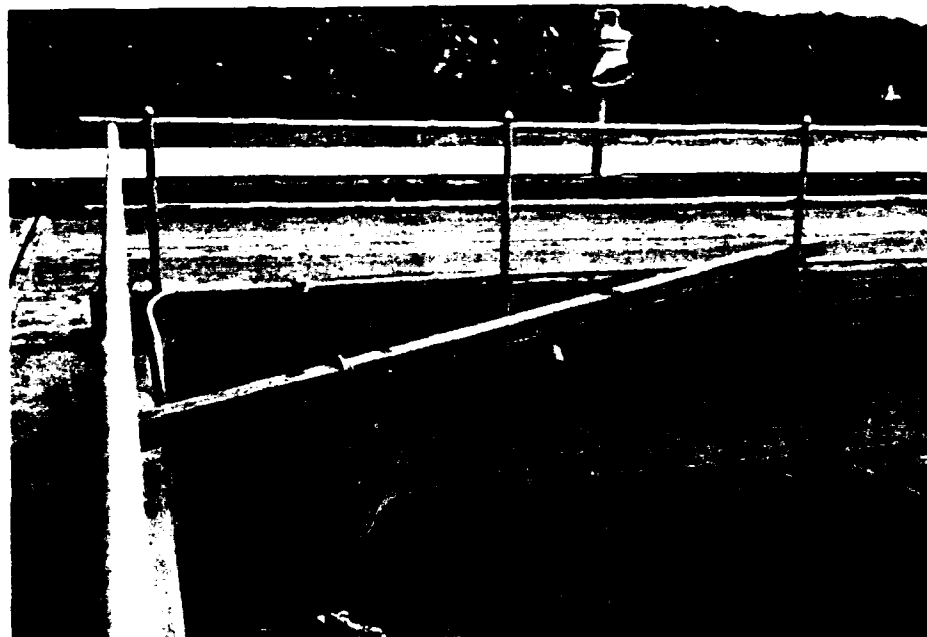
SPAN NO. 2 - APPROACH ROADWAY  
Longitudinal Crack in Facia Beam, About 60 Feet Long,  
to Be Chipped Out and Epoxy Patch Repaired.
